# ASSESSMENT OF DAM SAFETY OF COAL COMBUSTION SURFACE IMPOUNDMENTS

**Gulf Power  
Plant Scholz  
Sneads, Florida**

Prepared for  
*U.S. Environmental  
Protection Agency  
Washington, D.C.*

October 2012

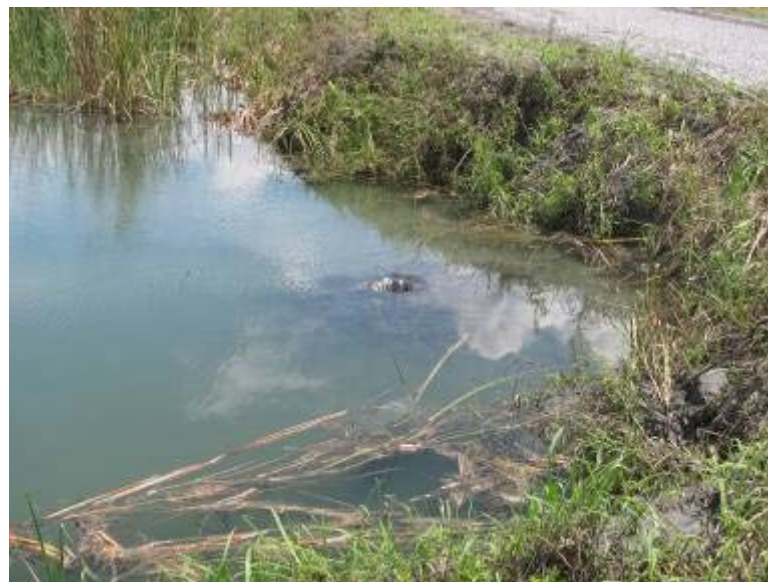
The Upper West Pond outlet structure consists of an 18-inch morning glory-type steel pipe located at the southwest corner of the pond (Photograph 74). The riser appeared to be free of debris and in good operating condition.

Photo 74: Upper West Pond – Southwest embankment interior slope, morning glory-type drop inlet structure looking southeast.

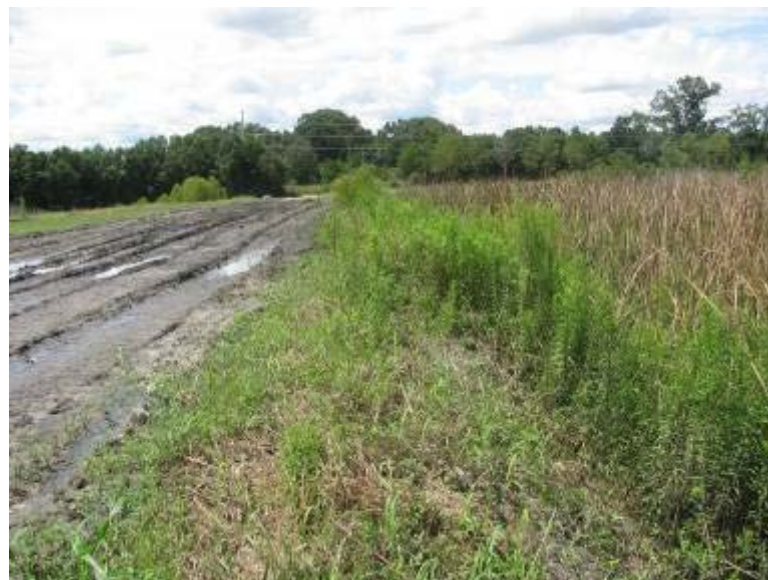
The crests of the Upper Middle Pond appear to be in satisfactory condition. The average crest width is approximately 22 feet. Slight depressions and ruts with standing water (Photographs 79 80, 83 and 85) were observed on the crest of the divider embankment between the Upper Middle Pond and the Upper West Pond. No evidence of settlement or cracks was observed on the crests. Signs of heavy equipment traffic were present on the crest of the east divider embankment (Photographs 93 to 95 and 104).

The crest of the Upper West Pond appears to be in fair condition, with some areas of rutting and signs of heavy equipment traffic on the south divider embankment between the Upper Middle Pond and the Upper West Pond (Photographs 79 and 80). The average crest width is approximately 25 feet. The crest of the west embankment is gravel-covered without vegetation. The east embankment crest is surfaced with compacted gravel and is used as an access road. Sparse vegetation was growing in the middle and on both sides of the roadway (photo 88).

Photo 80: Crest and interior slope of divider embankment between Middle Pond and Upper West Pond, looking northwest.

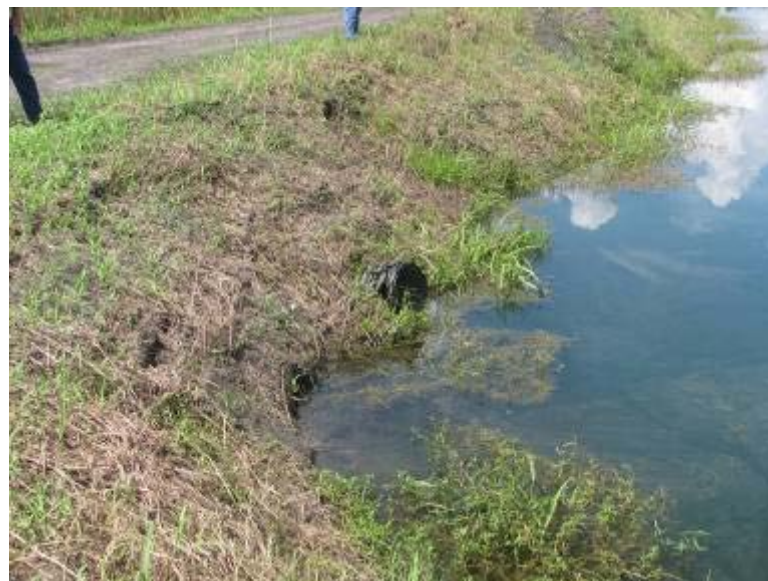
The outlet from the Upper Middle Pond consists of an 18-inch diameter corrugated HDPE pipe located near the southwest corner of the pond (Photograph 82). The pipe appears to be in good condition.

Photo 82: Upper Middle Pond – Divider embankment interior slope, 18-inch diameter corrugated HDPE outlet pipe looking northwest.

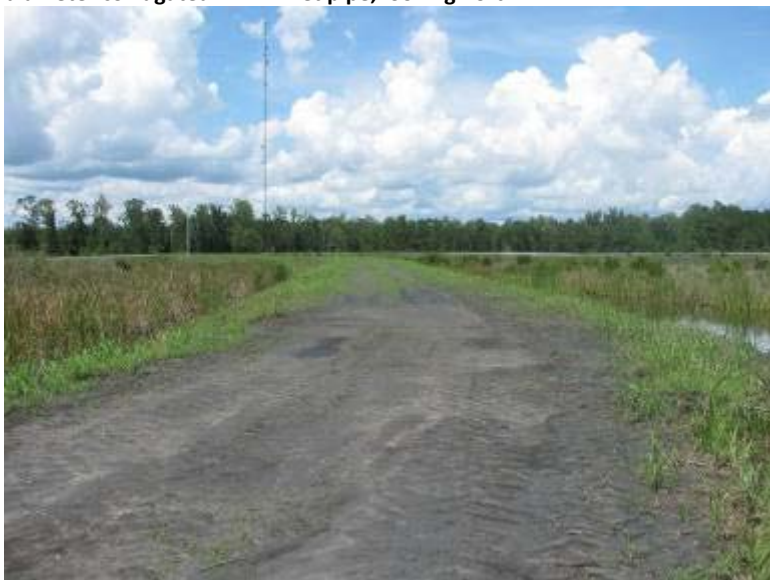
Photo 83: Crest of divider embankment between Upper West Pond and Upper Middle Pond, looking north.

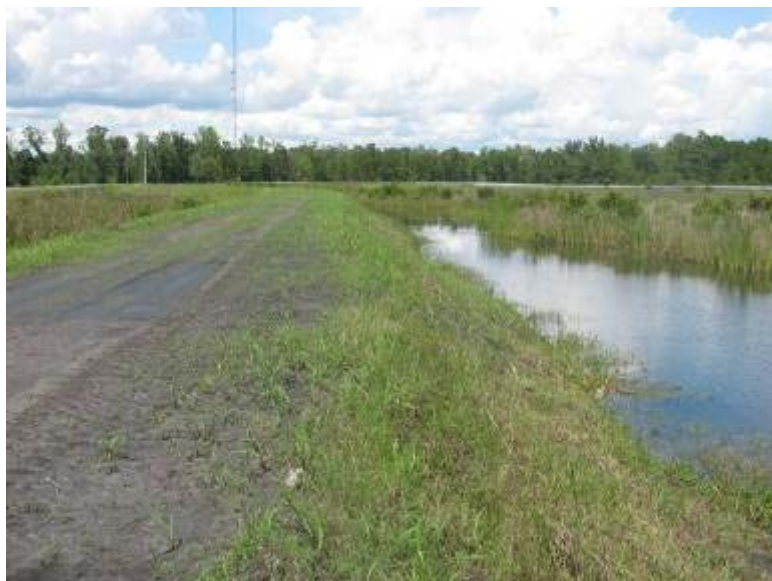
Photo 85: Upper Middle Pond – Divider embankment interior slope and crest, looking north.

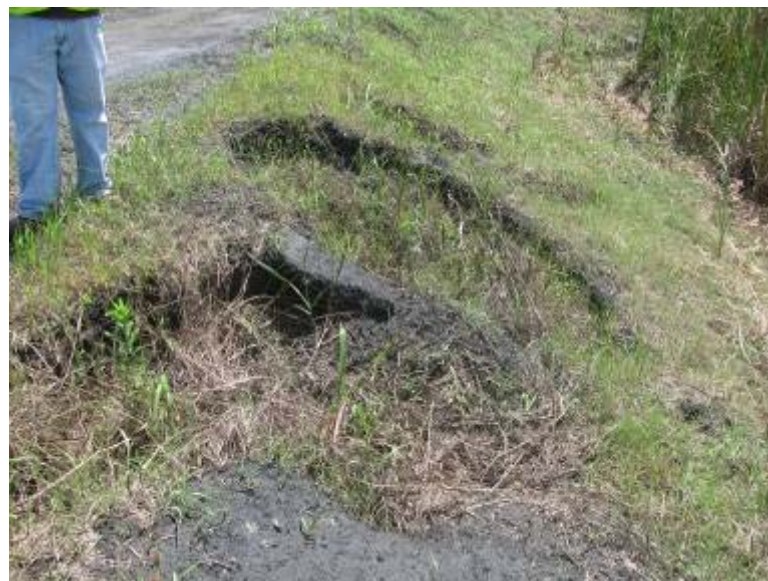
Photo 86: Upper Middle Pond – Divider embankment interior slope looking north. Typical of four scarps along approximate 50-foot length of slope.

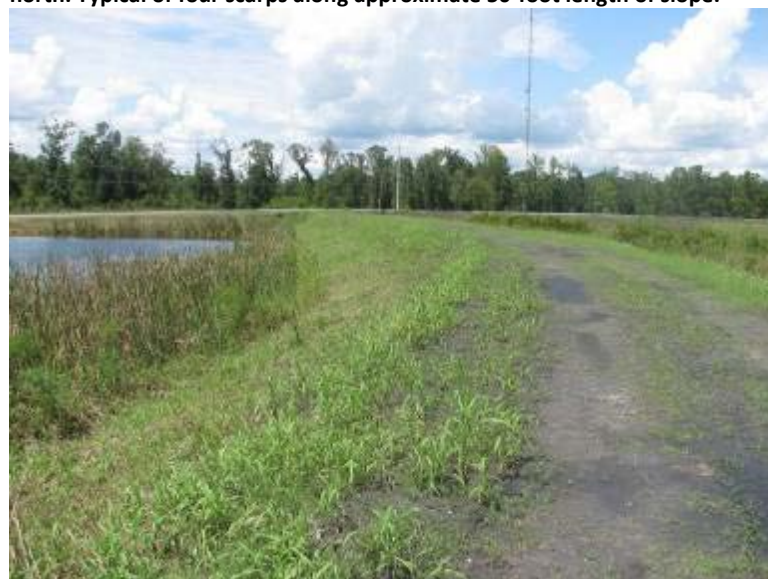
Photo 88: Upper West Pond – Divider embankment interior slope and crest, looking north.

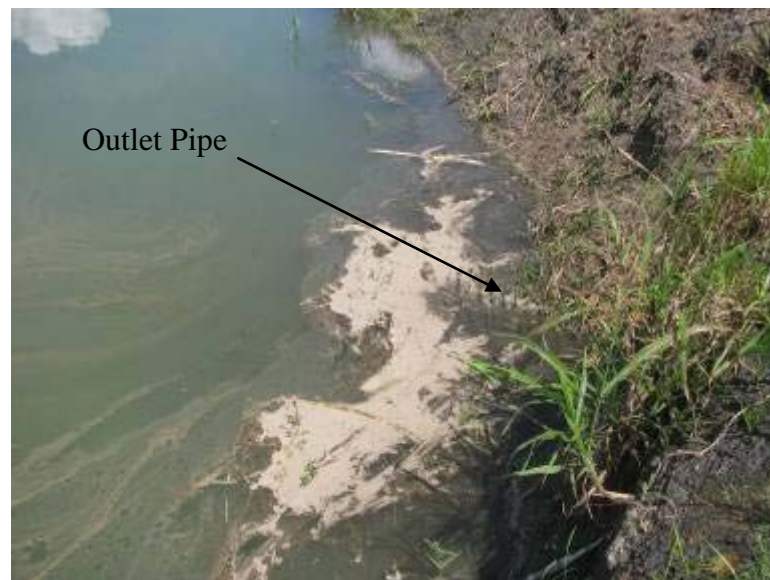
The outlet pipe consists of an 18-inch HDPE corrugated pipe (Photograph 90). The pipe was submerged at the time of visual assessment and is located near the northwest corner of the Upper East Pond. The pipe appears to be in satisfactory condition.

Photo 90: Upper East Pond – Divider embankment interior slope, 18-inch diameter corrugated HDPE outlet pipe, looking east. Pipe is submerged.

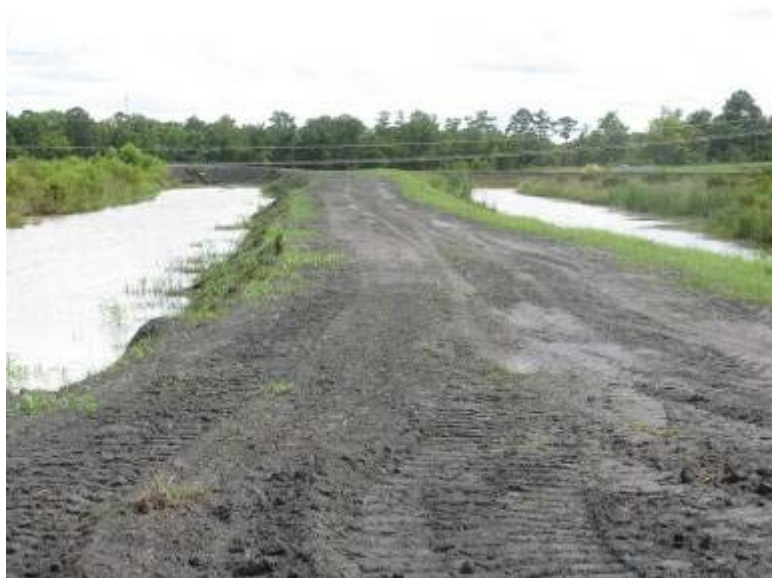
Photo 93: Crest of divider embankment between Upper East Pond and Upper Middle Pond, looking south.

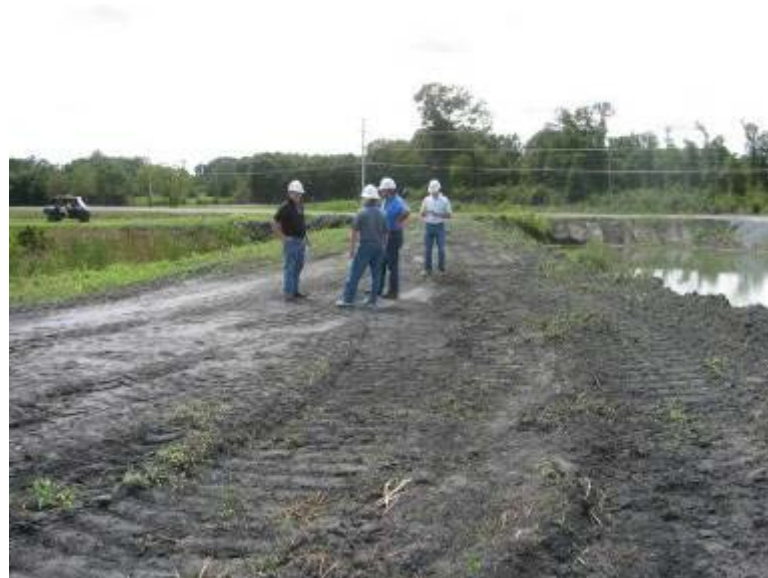
Photo 94: Crest of divider embankment between Upper East Pond and Upper Middle Pond, looking west.

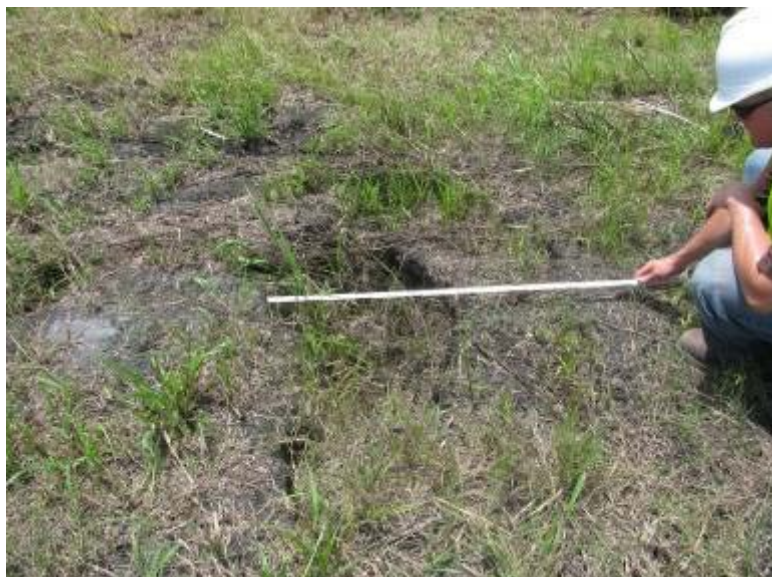
The interior slopes appear to be in fair condition. The interior slopes appear to be approximately 2H:1V. Short grass covers the interior slopes. Shallow erosion rills (Photographs 101 and 102) were observed along the interior slope of the west embankment with an approximate frequency of one every 50 feet. Areas of surface erosion were observed on the west embankment (Photograph 86 and 87) and also were observed at the northwest corner of the pond (Photograph 89) around the 18-inch diameter corrugated HDPE inlet pipe. Water was flowing thru the pipe from the Upper East Pond.

Photo 101: Upper Middle Pond – Divider embankment interior slope, 2-foot x 2-foot x 6-foot long erosion rill, looking west.

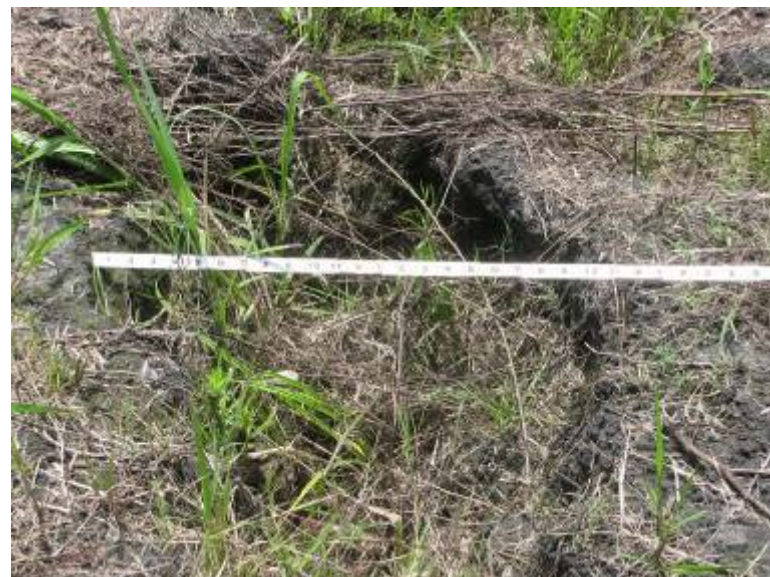
Photo 102: Upper Middle Pond – Divider embankment interior slope, close up of erosion rill, looking west.

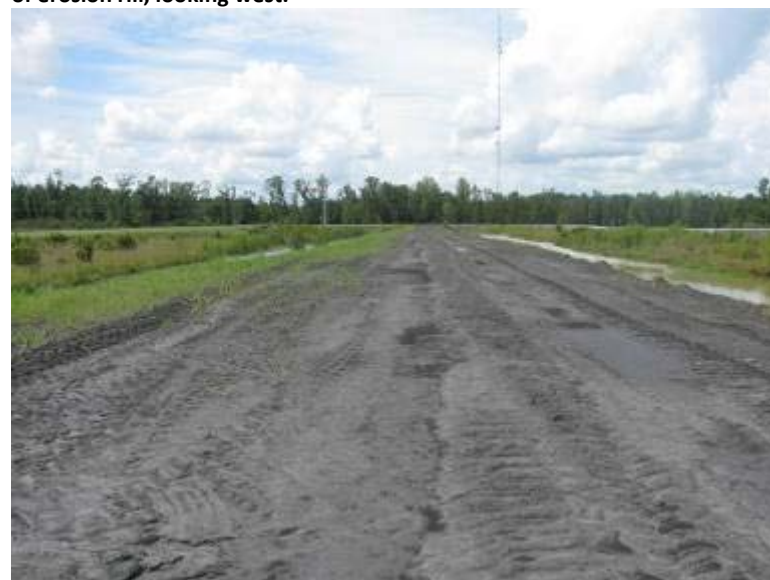
Photo 104: Crest of divider embankment between Upper East Pond and Upper Middle Pond, looking north.

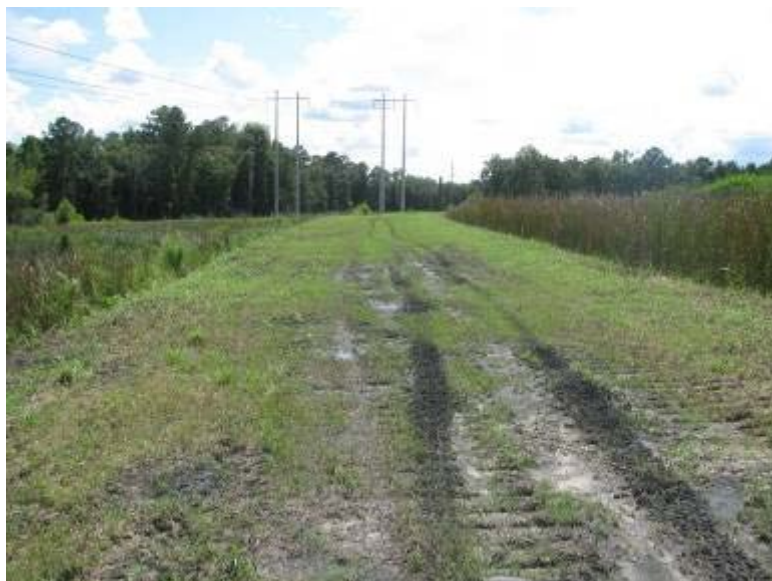
The crest of the Middle Pond appeared to be in good condition (Photographs 115 and 116). The average crest width is approximately 25 feet. The southwest and west crests are gravel-covered with sparse short grass. The crest of the divider embankment between the Middle Pond and the Lower Pond appeared to be in good condition. The crest of the west embankment of the pond is nearly level with the natural ground elevation west of the pond area. The north and southeast divider embankments seem to be constructed of soil and ash mix; no gravel was observed in this crest. No depressions or evidence of settlement were observed on the crests. Ruts and tire tracks were observed on the southeast divider embankment (Photographs 28, 109 and 110).

Photo 109: Crest of divider embankment between Middle Pond and Lower Pond, looking southwest.

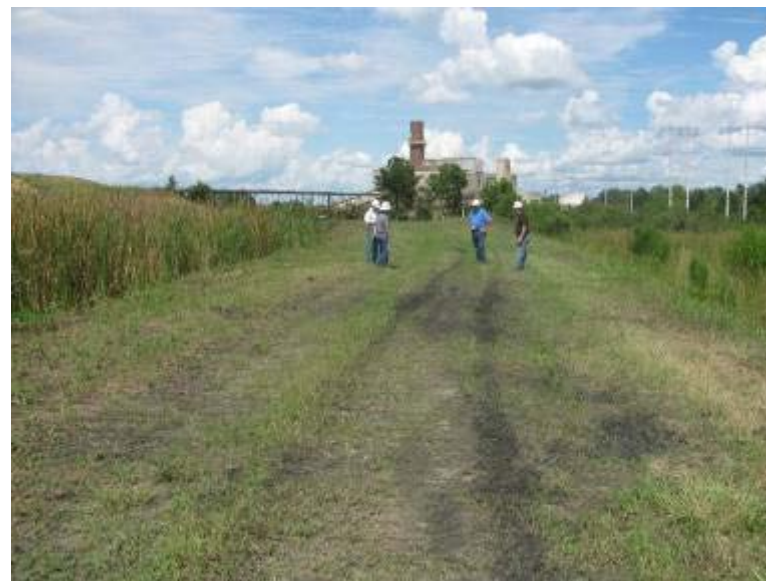
Photo 110: Crest of divider embankment between Middle Pond and Lower Pond, looking northeast.

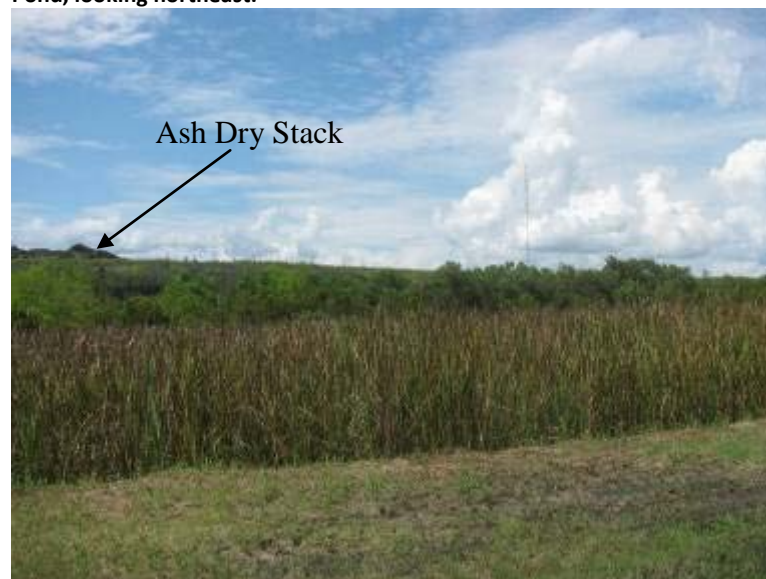
The Upper Middle Pond is situated between the Upper East Pond, the Upper West Pond, and the Middle Pond, sharing common divider embankments with these adjacent ponds as shown on Figure 4. The exterior slopes of the Upper Middle pond are the interior slopes for the Upper East and Upper West ponds at the north, east and west respectively. Exterior slopes at the south, are the interior slopes of the Middle Pond beyond the Ash Dry Stack. The Ash Dry Stack Area ground surface is approximately at crest elevation. The slopes of the Ash Dry Stack area towards the Middle Pond were not accessible to visual assessment due to the dense vegetation at the Middle Pond surface. These slopes appear to be very steep, nearly vertical, (Photographs 111 and 112) when observed from a distance.

The interior slopes of the pond appear to be in poor condition. Significant surface erosion and scarps (Photographs 37, 38 and 40 to 42) were observed on the east corner and on the north and northwest embankments adjacent to the Ash Dry Stack. Due to the high vegetation and proximity to the Dry Ash Stack area, the slope was not accessible but appears from a distance to be very steep (Photographs 111 and 112). The Ash Dry Stack appears to cover the Middle Pond north divider embankment.

Photo 112: Southside of Ash Dry Stack area, looking northeast. Slope along South side of Ash Dry Stack area is nearly vertical and inaccessible.

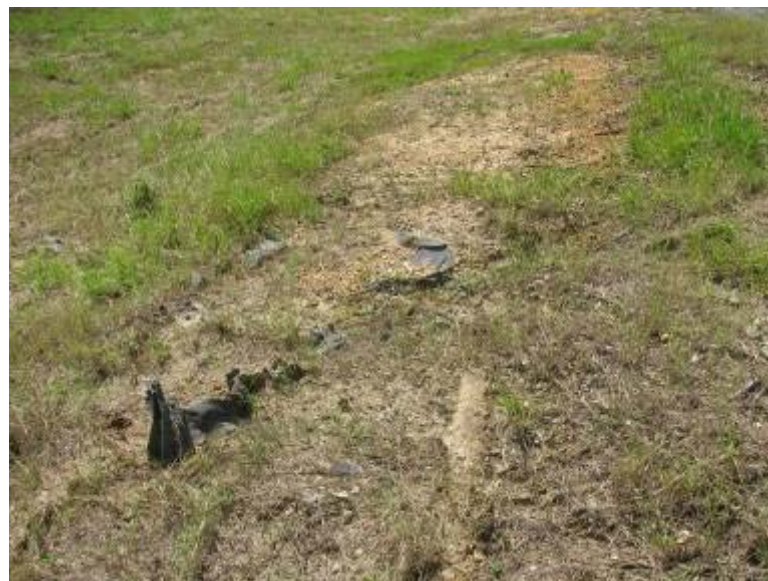
Photo 114: Middle Pond – West embankment exterior slope, trash and miscellaneous debris looking northwest.

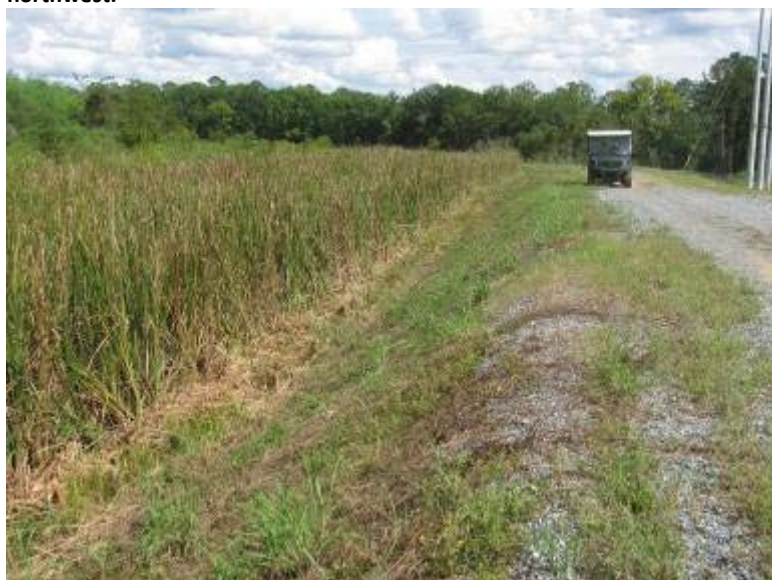
Photo 115: Middle Pond – West embankment interior slope, crest looking southeast.

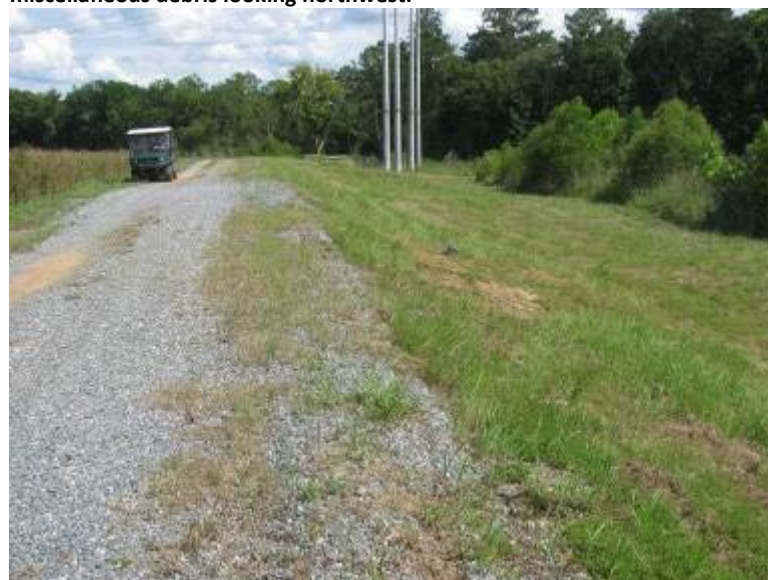
Exterior slopes of the Middle Pond appear to be in good condition. Slopes are approximately 4H:1V. Exterior slopes are covered with grassy vegetation about 4 to 6 inches tall (Photograph 116).

Photo 116: Middle Pond – West embankment exterior slope, crest looking southeast.

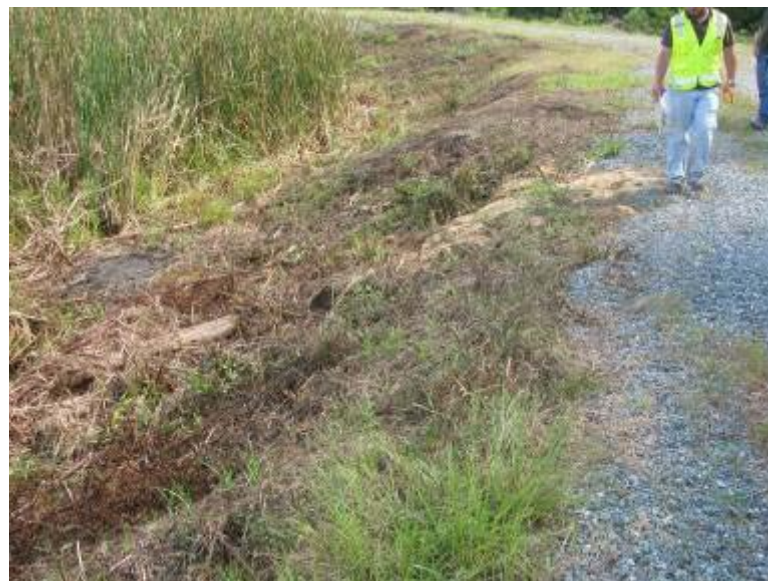
Photo 118: Middle Pond – West embankment interior slope scarp, looking south.
